6.– Risk Assessment

Introduction

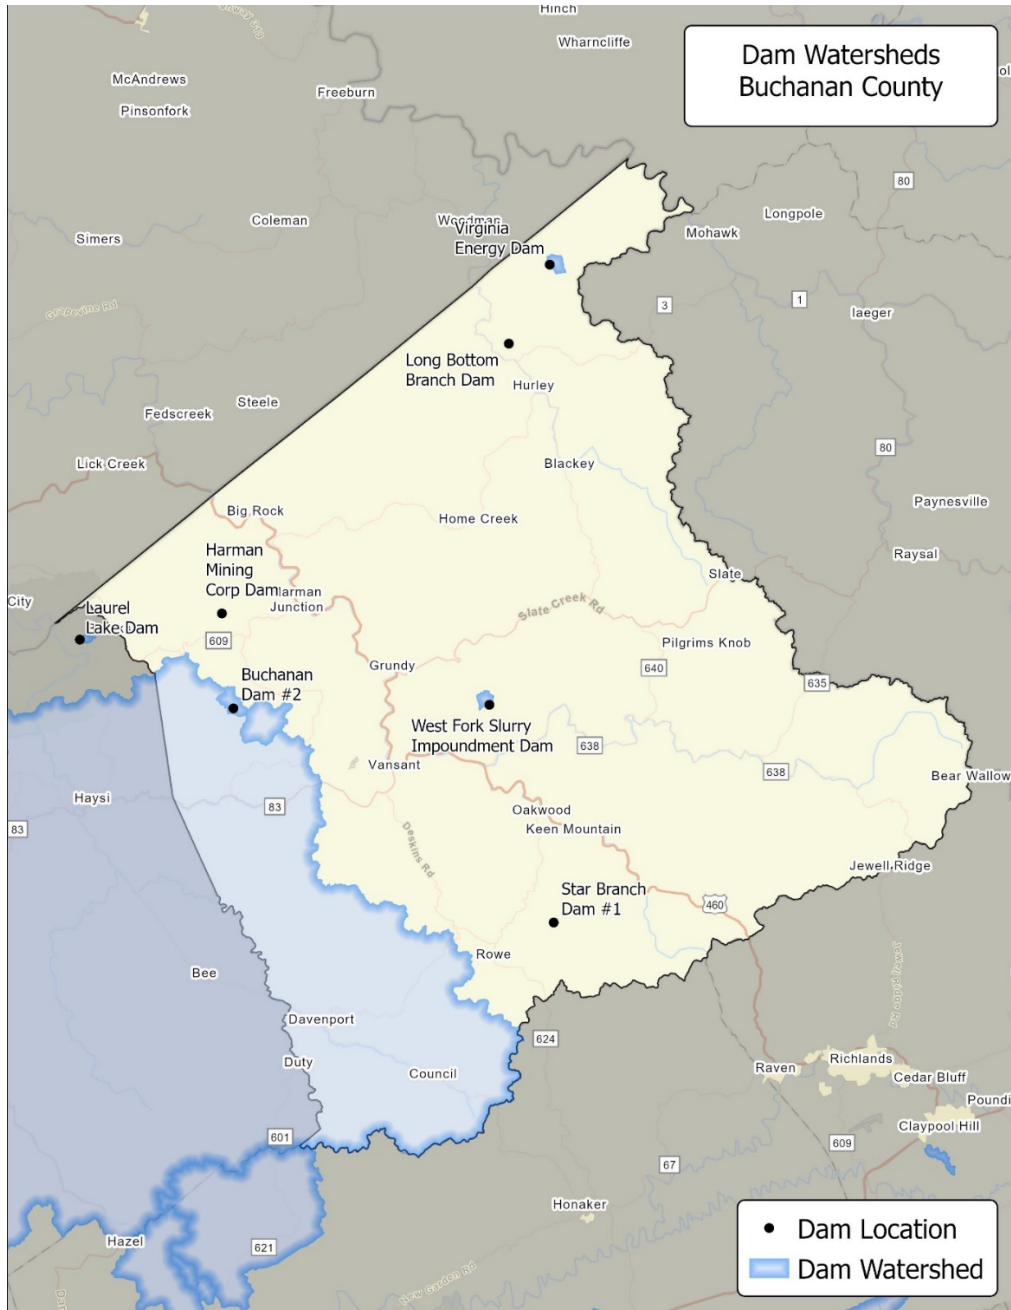
Figure 6-11: Dam Watersheds in Buchanan County

Dam watersheds are generated for most dams in Virginia by the Virginia Department of Conservation and Recreation's (DCR) Dam Safety program. These watersheds are shown below in Figure 6-11. Watersheds are not the same as inundation areas; the watersheds show the area that drains into each respective dam's reservoir. A heavy rain event in these areas would add increased strain on the associated dam.

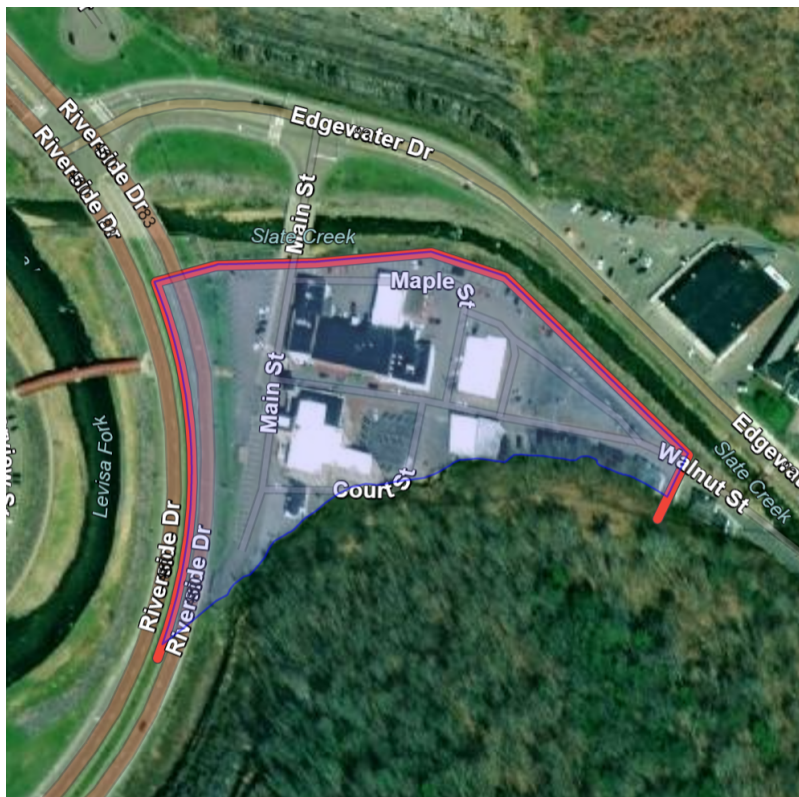
Figure 6-12: System and Area Protected by Grundy Levee System

Based on information available through the National Levee Database (NLD), there is one levee present in Buchanan County, located in the Town of Grundy. The Grundy levee system is located on the right descending bank of the Levisa Fork of the Big Sandy River and reduces flood risk within Grundy. The project was completed in 2008 by the federal government in response to the devastating flood of April 1977. The levee is owned, operated and maintained by the Town of Grundy. The system consists of 787 feet of concrete floodwall and 607 feet of levee/highway. It has one pumping station and two traffic openings that must be closed quickly during a flood event.

The US Army Corps of Engineers (USACE) has assessed this levee system to be low risk. It is 15 years old and has not yet been tested during a major flood. Flash flooding on the Levisa Fork can cause flood waters to rise very rapidly to unpredictable heights. The NLD summary estimates the population behind the levee (within the shaded area shown in Figure 6-12 below) to be 20, with seven buildings and property values at approximately \$4.7 million.²¹ In addition to data available from the NLD, FEMA maps areas of reduced risk due to levees on FIRMs. This area is assessed in the *Flood Hazard Analysis* section.

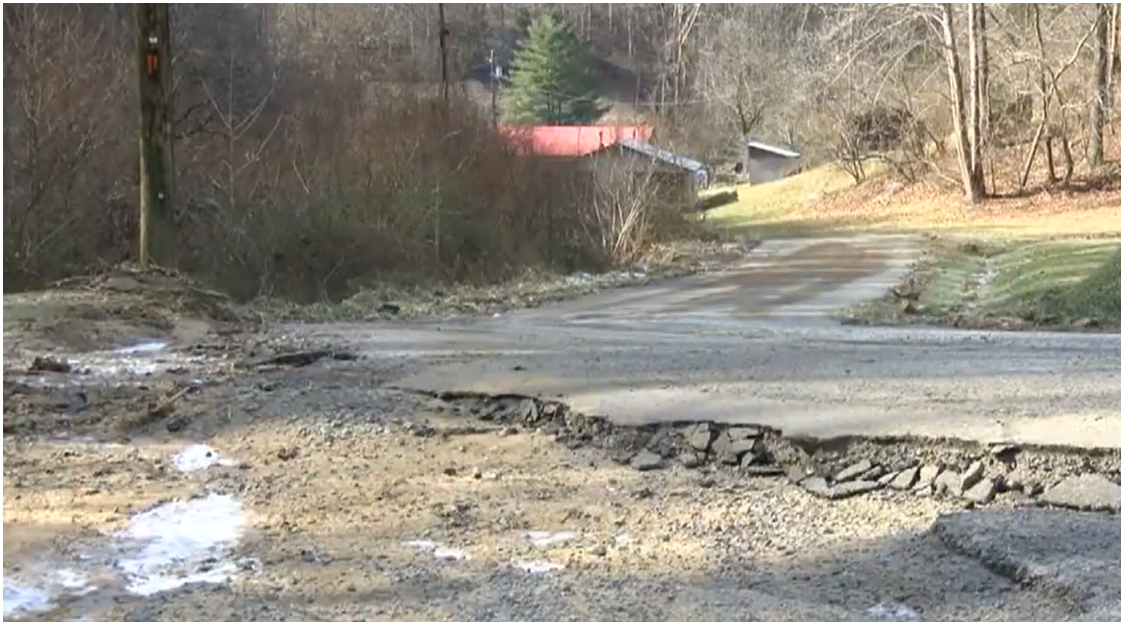
Figure 6-14: 2019 mine blowout damage near Hurley, VA

Local news covered one of these incidents as recently as 2019, which resulted in four feet of water rushing down a neighborhood road. A Buchanan County Board of Supervisors member pointed out that at least three major floods in recent years were caused by mine blowouts or mining pond failures. Figure 6-14 illustrates some of the damage caused by the 2019 blowout. Although not pictured, the incident damaged some homes, stranded one resident due to their driveway being washed out, and one elderly woman was forced to be evacuated.²⁶ Figure 6-15 provides a map of various mine openings (any opening or entrance from the surface into an active, or abandoned, underground mine) identified by the DMME. These openings allow precipitation and runoff to enter underground mines, potentially leading to a mine blowout. It is likely that there are more mine openings and portals throughout the county.

Mine blowouts, in addition to the damage caused by the force and volume of flood waters, produce mudslides which leave large amounts of sediment on roads, private or public property, and can block normal streamflow.

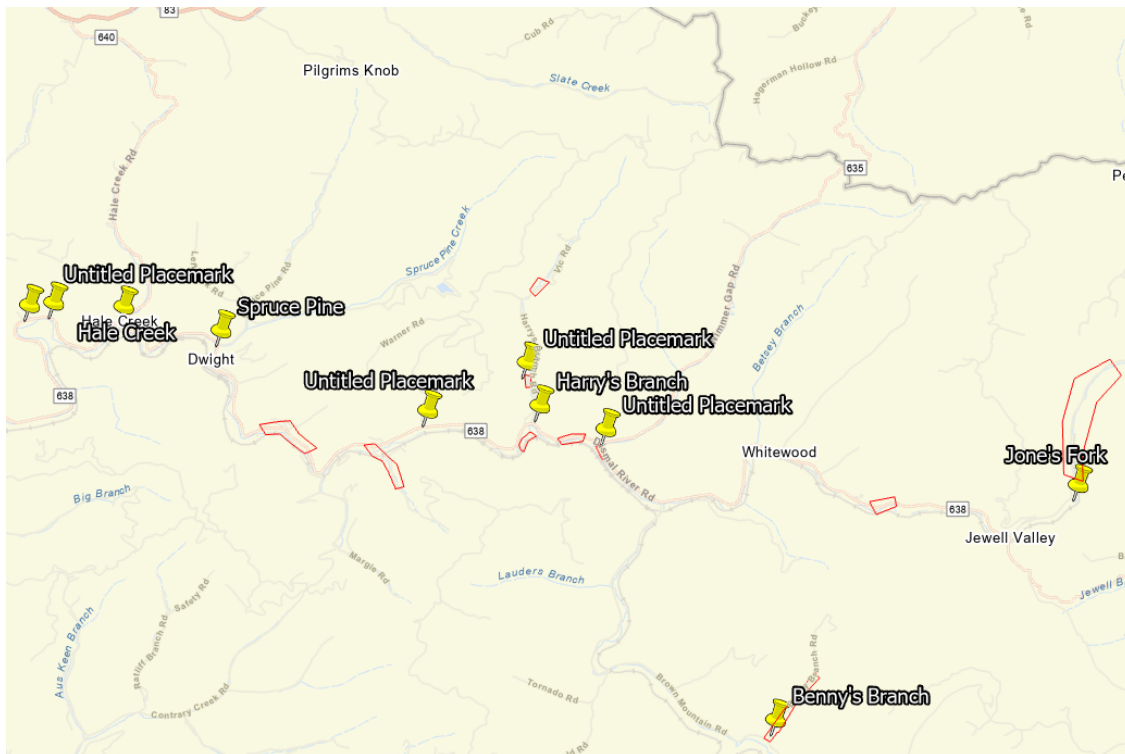
Severe flash flooding impacted the Whitewood, Pilgrim's Knob, and Jewell Valley areas of Buchanan County in after several days of heavy rainfall, resulting in significant damage. According to local news reports, the area received up to six inches of rainfall within just a few hours. Between 100 and 125 structures incurred structural damage, one person was injured, and over 2,000 power outages were reported within the affected communities. For 24 hours after the event, 40 stranded residents were unaccounted for due to loss of cell service and roadways that were impassable due to high water. This event was declared a state emergency as well as a federal disaster. FEMA individual assistance was estimated at \$1.96 million and public assistance, primarily due to road and bridge damages, was estimated at \$14 million.²⁸ It should be noted that many of the areas impacted by this flood event were outside of FEMA mapped flood hazard areas. The events during and the aftermath following this storm were discussed in the public meeting. The area, with some of the comments from residents, are shown below in Figure 6-16.

Figure 6-16: Public meeting comments regarding July 2022 flood event

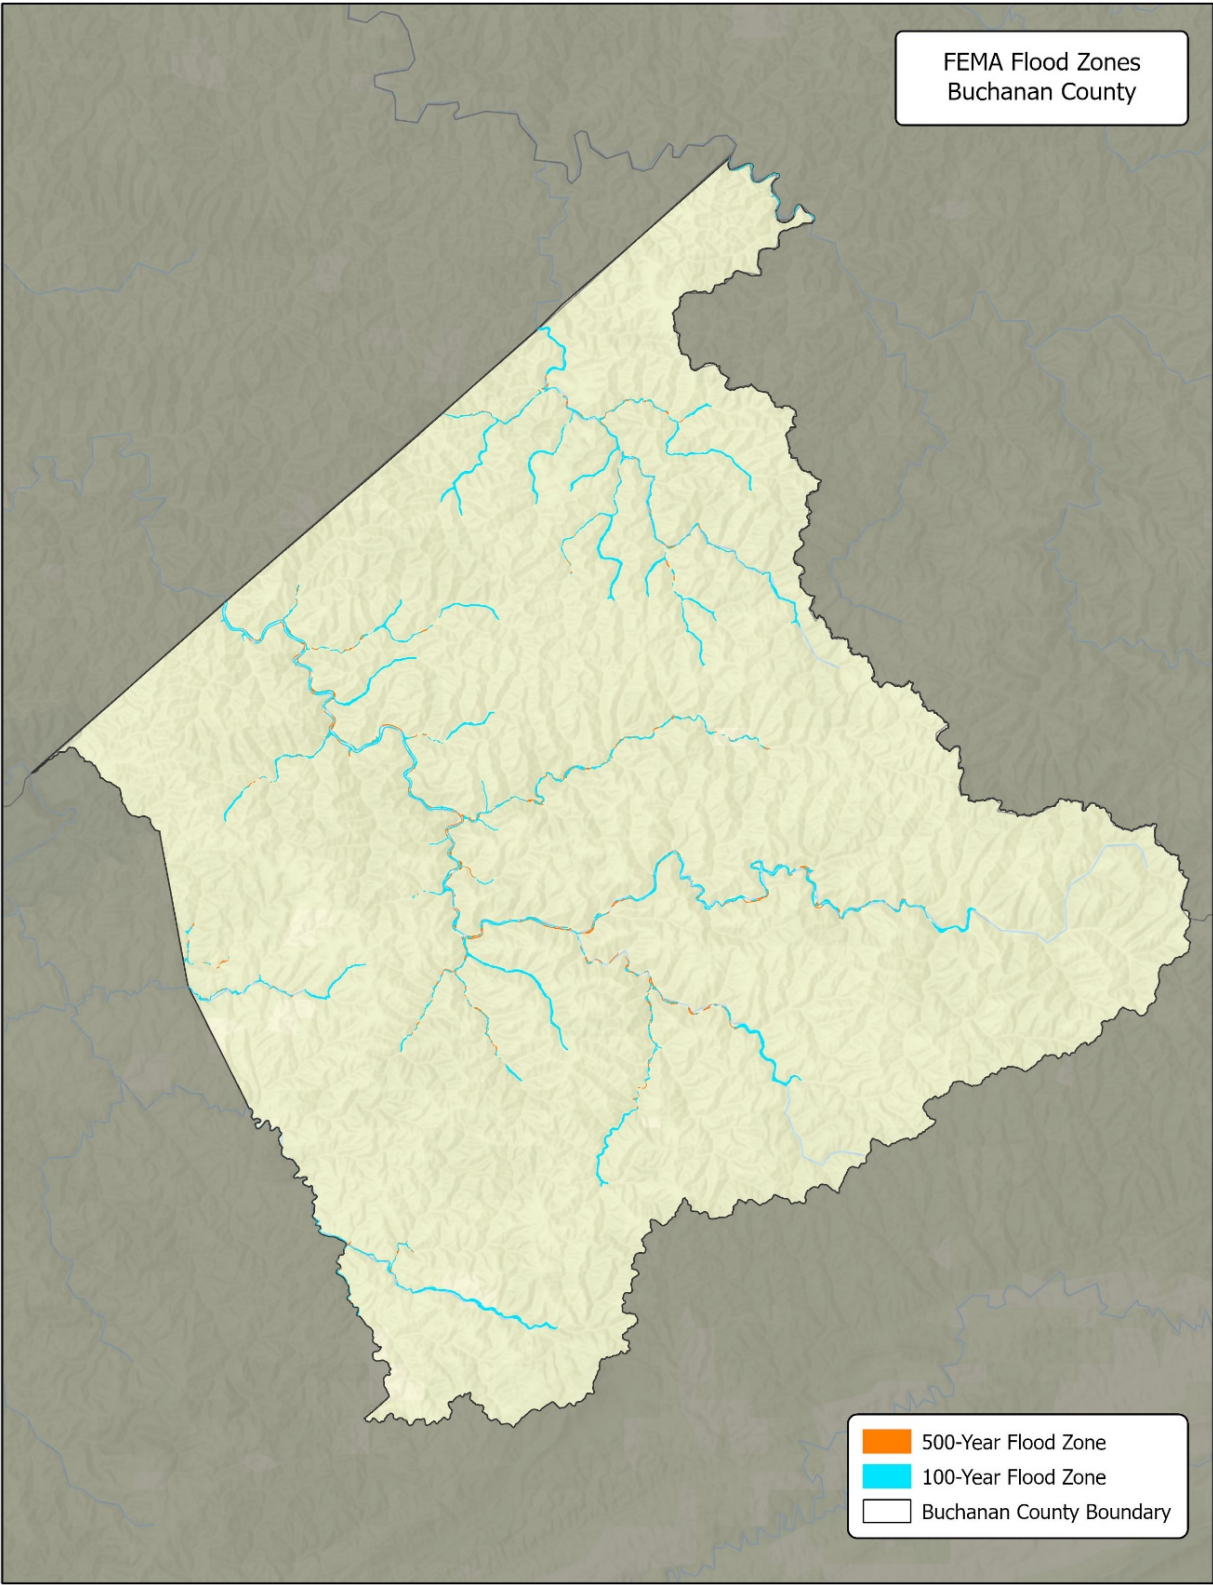
Figure 6-17: Buchanan County FEMA flood hazard areas

FEMA produces maps of special flood hazard areas based on riverine flooding. These include the areas with a 1.0% and 0.2% annual chance of flooding (the 100-year flood and 500-year flood zones, respectively). Given the county's development patterns, most development falls within one of these zones. Figure 6-17 shows the 100-year and 500-year flood zones located throughout the county.

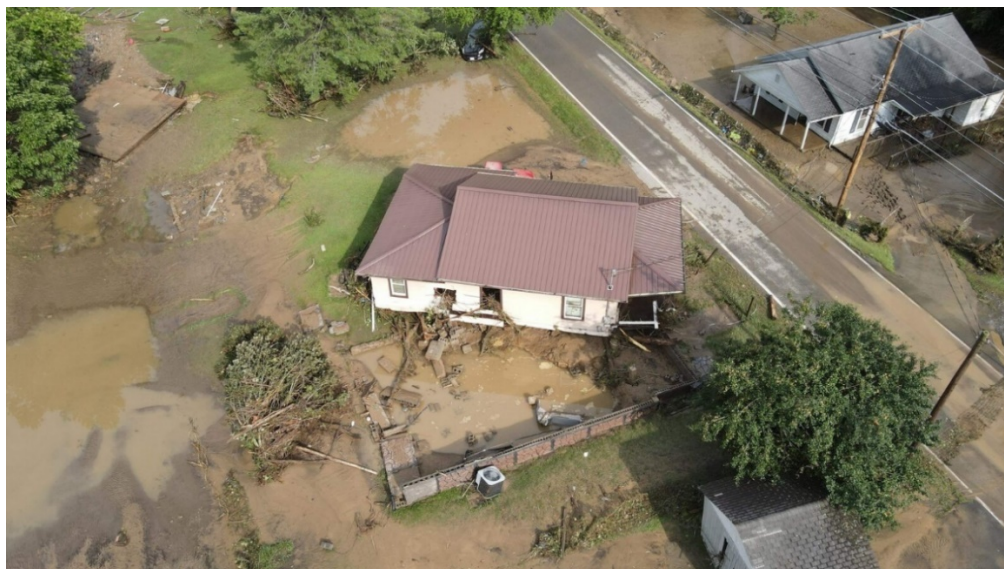
Figure 6-20: Buchanan County home that was pushed off its foundation during July 2022 flooding³⁴

Pressure from floodwater, especially as seepage through soil, can damage building foundations. Furthermore, as illustrated in Figure 6-20 and Figure 6-21, the force of rushing floodwaters can push whole structures off their foundations. Mobile homes and manufactured homes that are not elevated or properly anchored to a permanent foundation are more susceptible to being lifted up and carried hundreds of feet during a flood event. When this occurs, not only is the structure itself damaged or destroyed, but the structure then becomes a threat to other structures, property, and residents as it travels downstream.

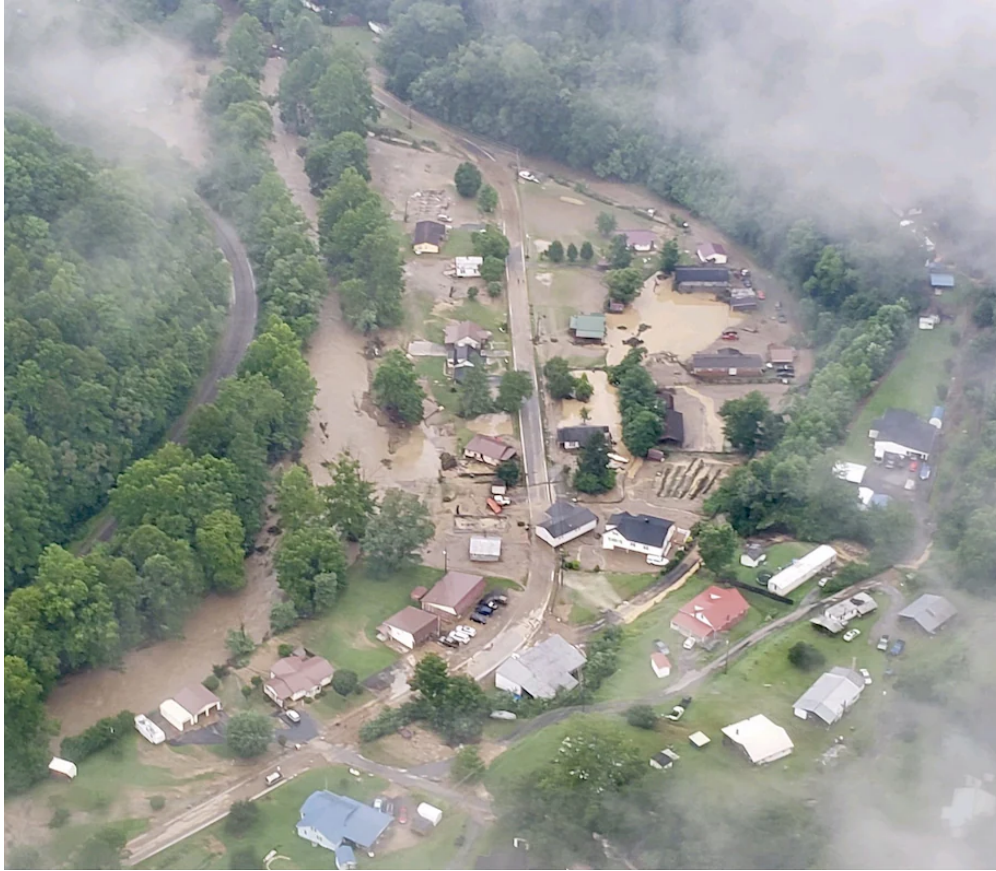
Figure 6-21: Flood damage resulting from July 2022 flooding in Pilgrims Knob area of Buchanan County³⁵

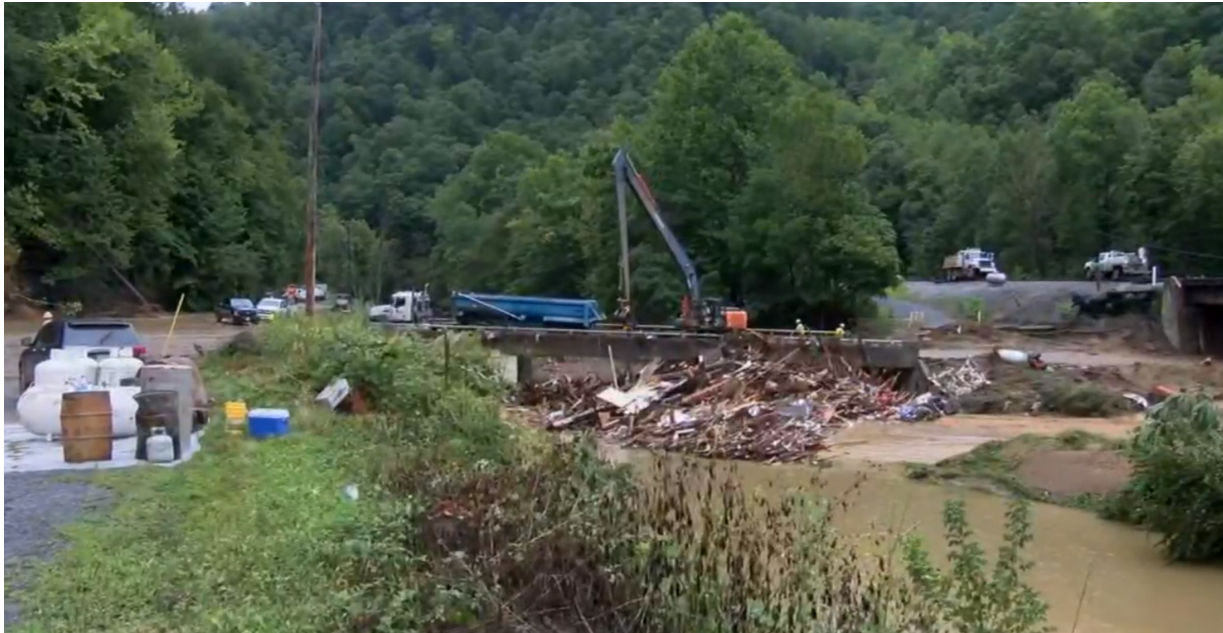
Figure 6-22: Debris collected at a bridge in Hurley, 2021³⁶

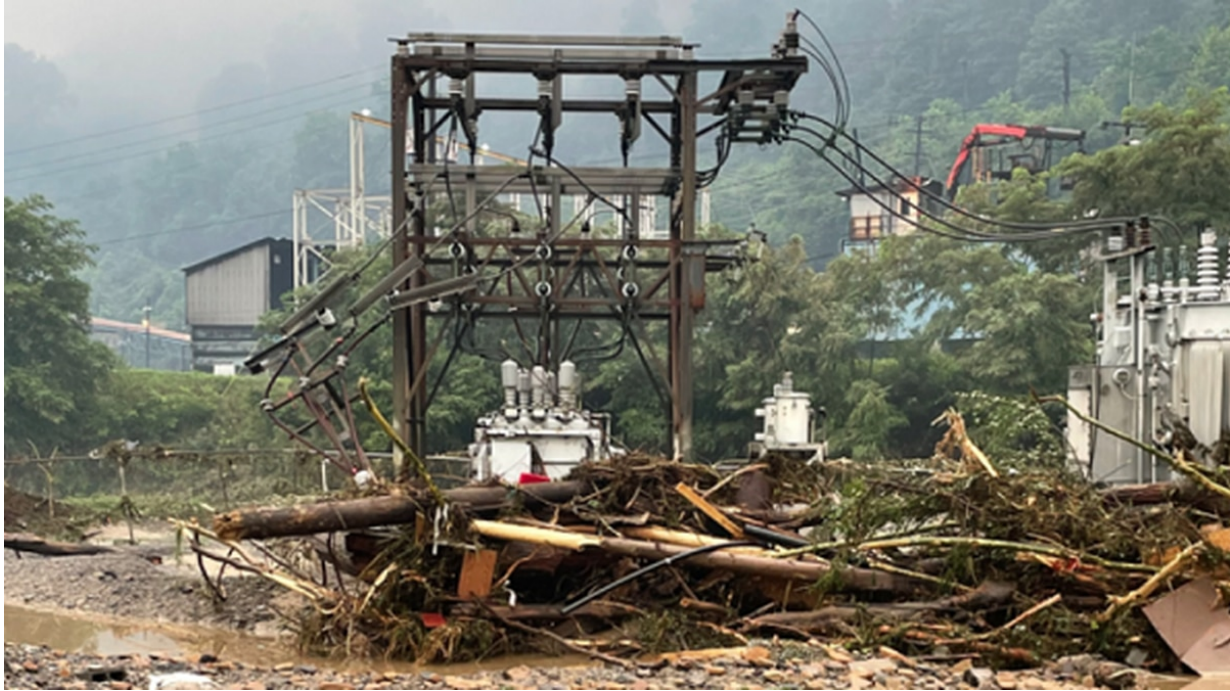
Figure 6-23: Flood damage at Appalachian Power's Dismal River Substation, 2022³⁷
